# Gegedzerick Open Day

LANDCARE LEADS THE WAY  
Sat, 25 March 2023

## Station 5 - Erosion Gully Repair + Hand Seeding

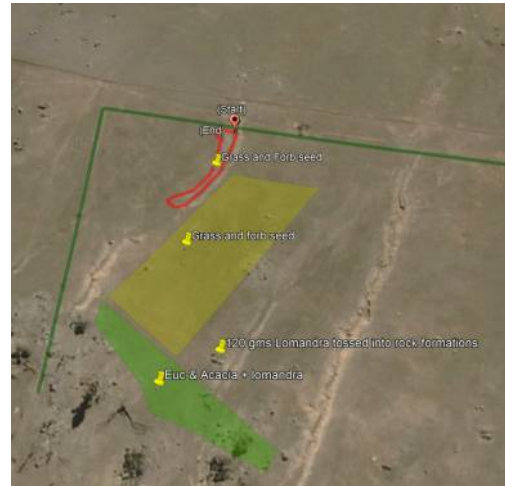
In the yellow (grassland) section between the erosion gullies a mix of 250g of native grass mix (same mix that was used in the hydromulcher) was added to various 'carriage' media (e.g. semolina, oatbran, lentils, amaranth, couscous, potting mix) in a 3:1 ratio to make it easier to disperse the seed by hand.

At 75 locations, each marked by a yellow flag, we scraped 3 separate spots in a triangle shape 30cm from the flag. A teaspoon of carrier-seed mix was broadcast in the spot and tamped down by foot. The same procedure, but without seed, was applied to 25 locations, marked by white flags, to act as controls.

In the green ("woodland" section), a tree seed mix (4g of seed, 36g of carrier medium) consisting of 3g Ribbon Gum (*Eucalyptus.viminalis*), 0.5g Blackwood Wattle (*Acacia melanoxydon*) and 0.5g Silver Wattle (*A. dealbata*) was applied at 75 locations marked by red flags. As above, 3 holes were scraped at approximately 30 cm from the flag in a triangle shape and a finger pinch of mixed seed was dropped into two holes and stamped down. Two *Lomandra* seeds were pushed in also. The remainder of the *Lomandra* seed (150g) was thrown into the crevices between the granite boulders in this area. At 25 locations (white flags), no seed was applied.

In the red polygon, a teaspoon of the same grassland mix was added to disturbed patches of the gully side following scraping. No flags were used.
